building survey *report*

THE CUBE CINEMA

4 PRINCESS ROW
BRISTOL
BS2 8NQ

Date: April 2011

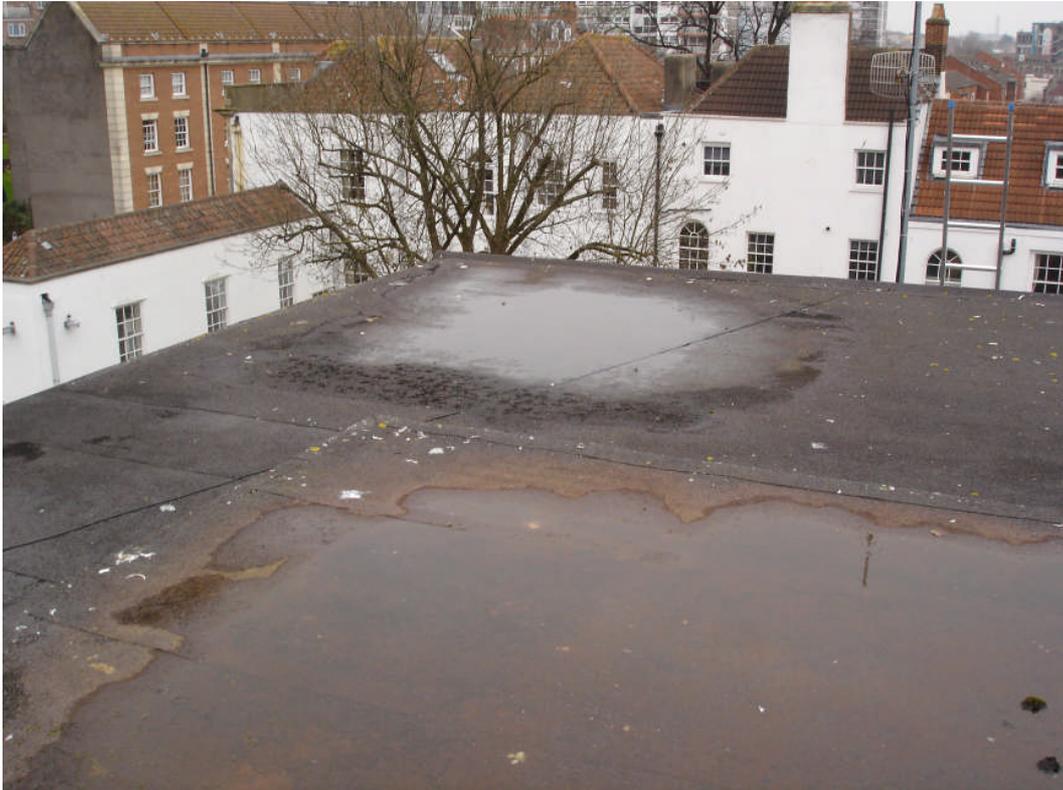
1 Fly Tower roof - overview

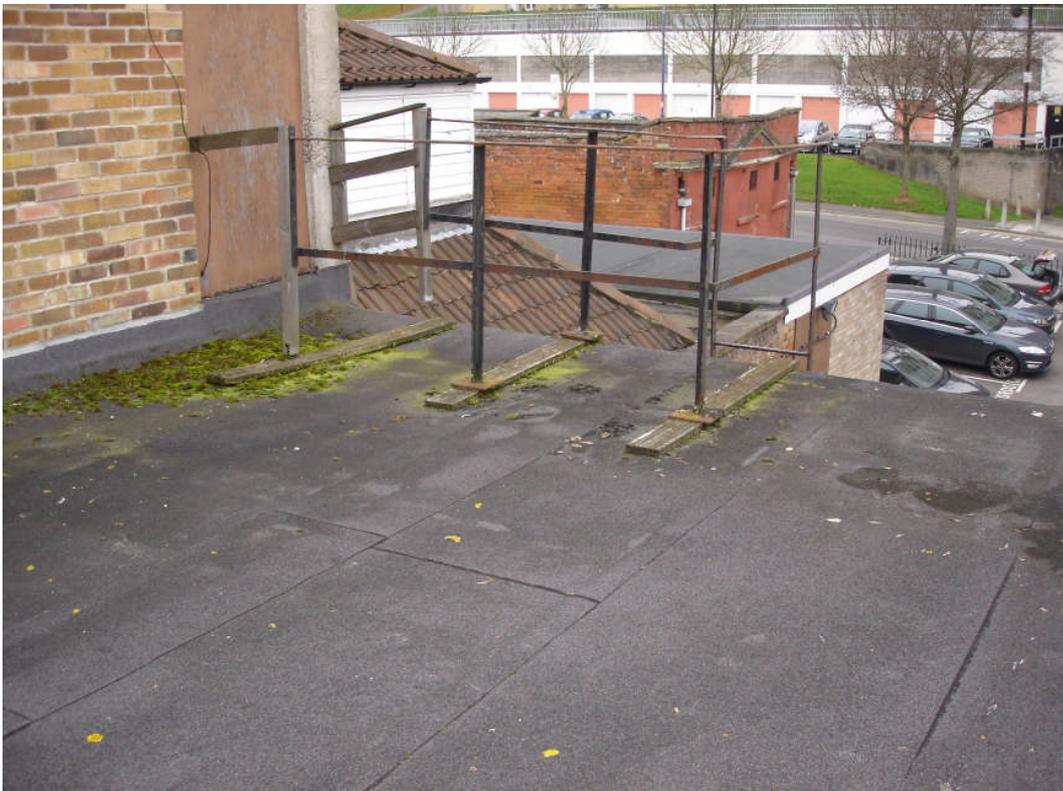
2 The Zone roof - overview

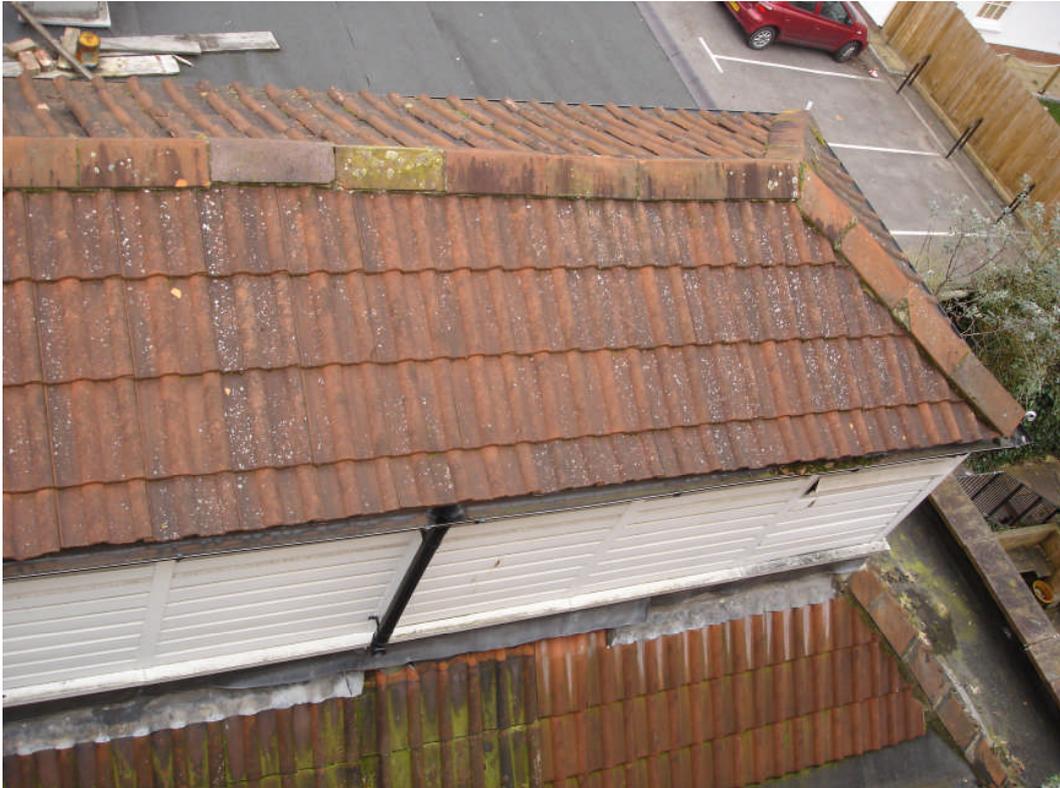
3 Auditorium roof – overview

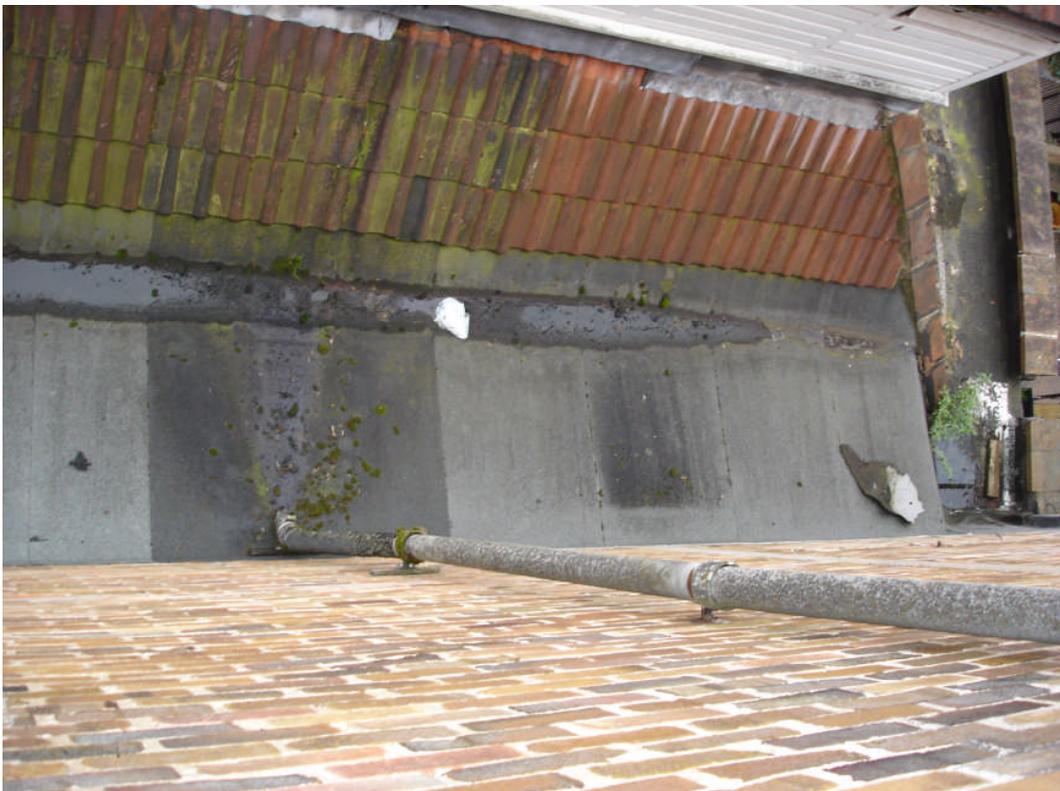
These coverings have been replaced over time and the present finishes are in poor condition; at the rear left hand corner, holes, back-falls and defective weatherings require immediate repair beyond simple patching but elsewhere, for other failed sections, patching may appropriate but only as a temporary measure.

4 Auditorium roof valley gutters – overview

In the very near future, these gutter linings need to be replaced completely; at that time provision must be made to investigate and repair damage caused by prolonged leaks and I fear that concealed woodwork may well have been compromised; the risks from timber decay are significant and full exposure of vulnerable elements is needed. This may cause damage to internal finishes.

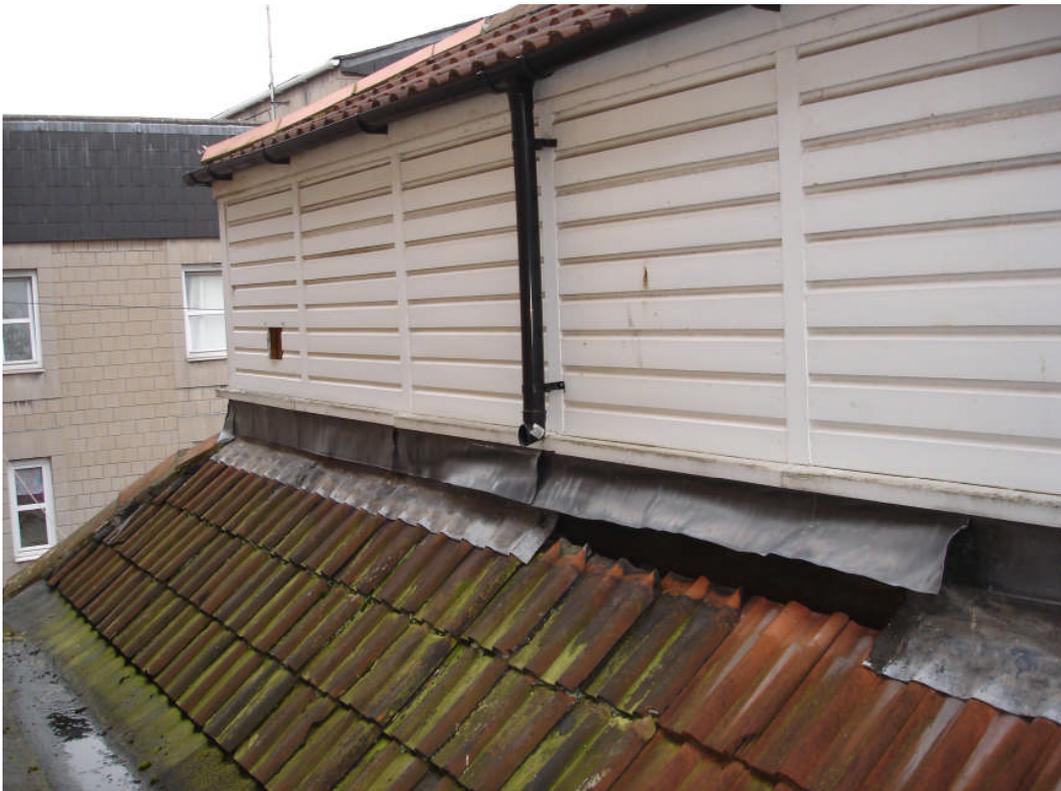
5 Auditorium roof – cladding and detailing defects

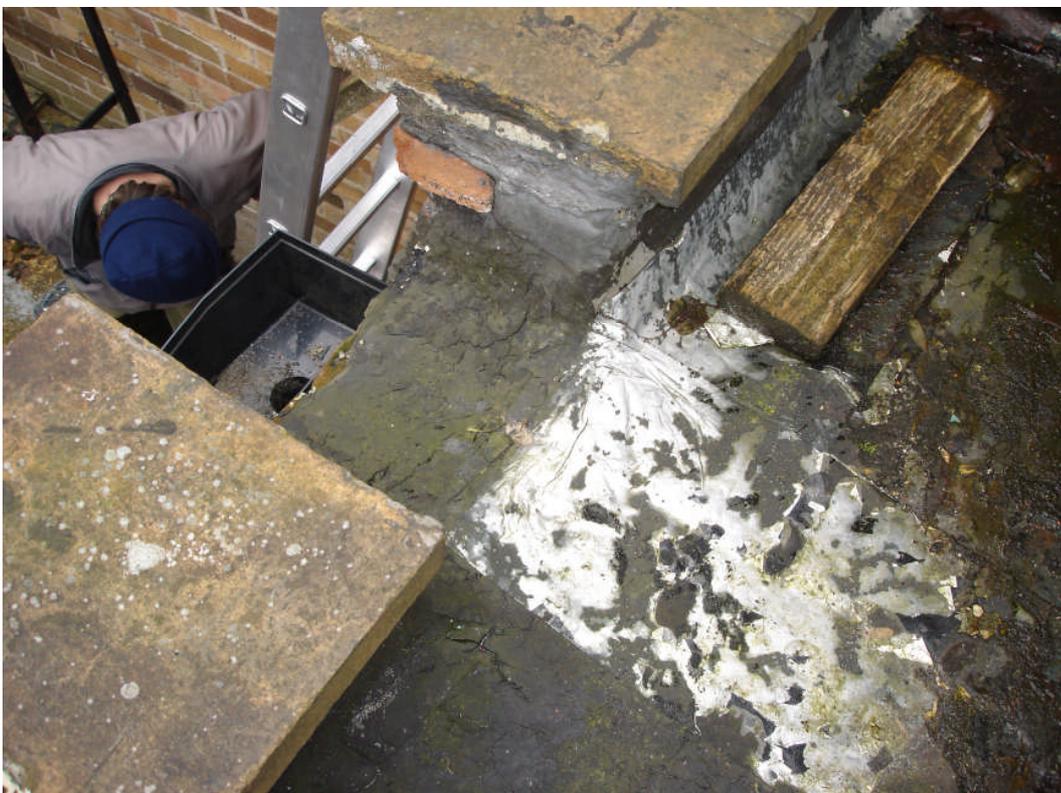
6 Auditorium roof – gutter detailing defects

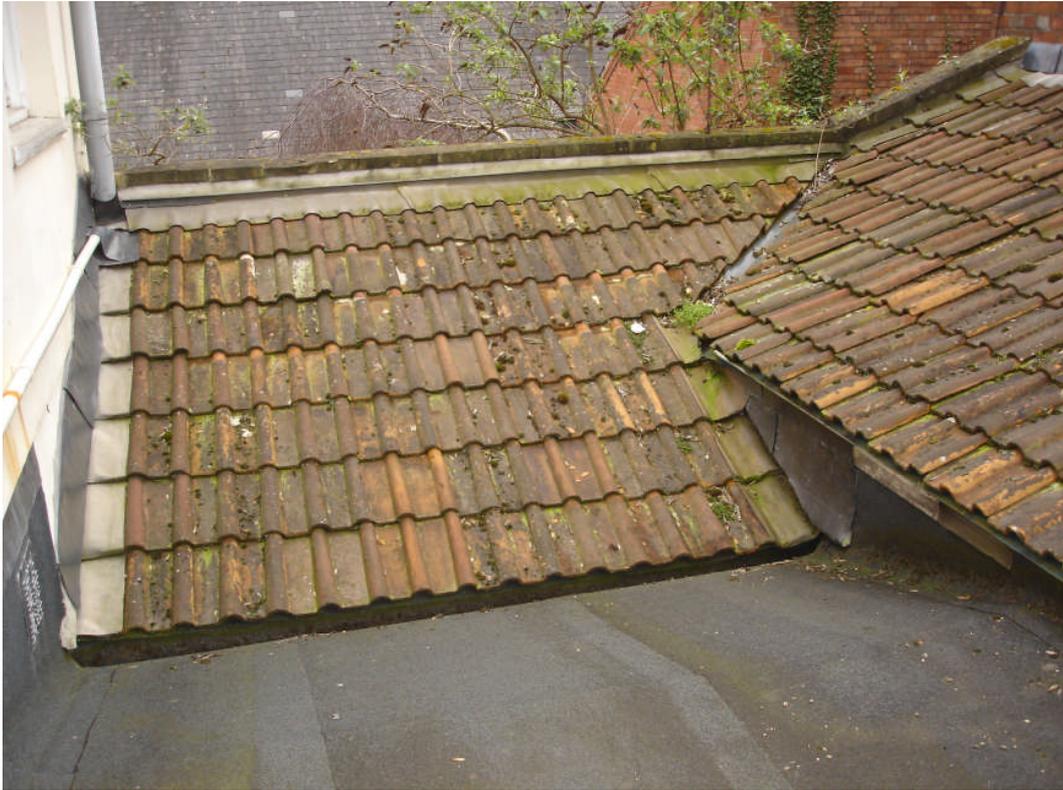
7 Roof over The Common Parts

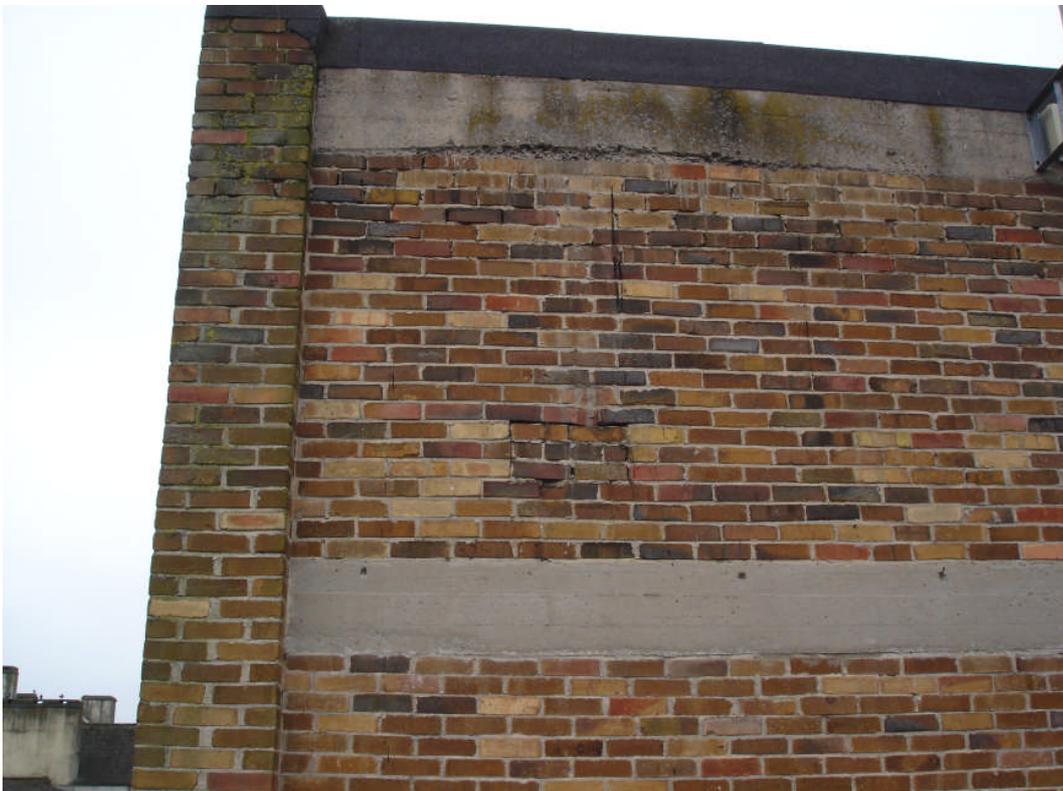
8 Walls to Fly Tower & The Zone – typical construction

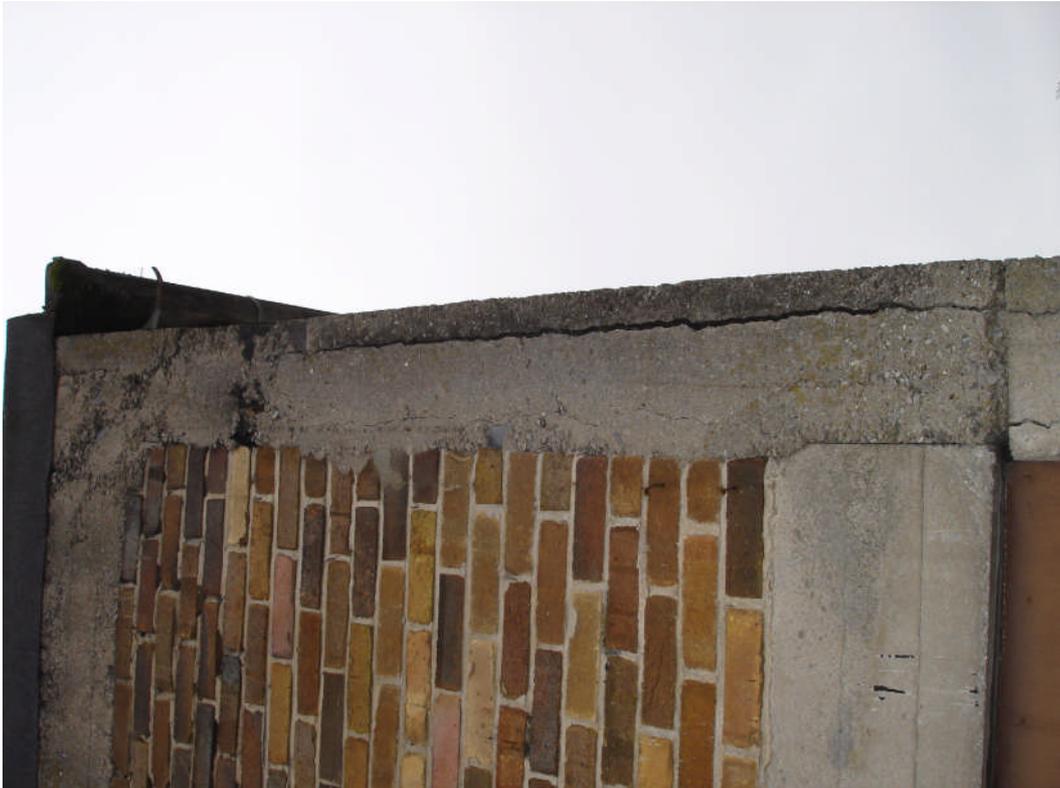
As the 2005 Whitby Bird report makes clear, the concrete elements are in very poor condition and it seems that the recommended repairs from five years ago have not yet been auctioned; the condition described by Whitby Bird remains evident and the recommendations for repairs are that much more critical now.

Where water is able to penetrate structural elements major and rapid deterioration is likely; the poor compaction of the concrete and the likely shallow cover to steel reinforcement has exposed the steel to direct water-induced corrosion and also carbonation, a process where CO₂ in the atmosphere is dissolved in rainwater forming carbonic acid which can progress through weak concrete converting the normally alkaline concrete to an acidic environment which induces further corrosion of the steel. We discussed the expansive forces of rust and not only does this reduce the steel sections (smaller sections normally mean weaker sections) but the expanding corrosion is bursting the concrete apart.

9 Walls to Fly Tower & The Zone – typical construction defects in reinforced concrete

There is an urgent need for reassessment of the entire reinforced concrete structure with a view to removing defective components, repairing what is left and stabilizing the building for a realistic future effective 'life'.

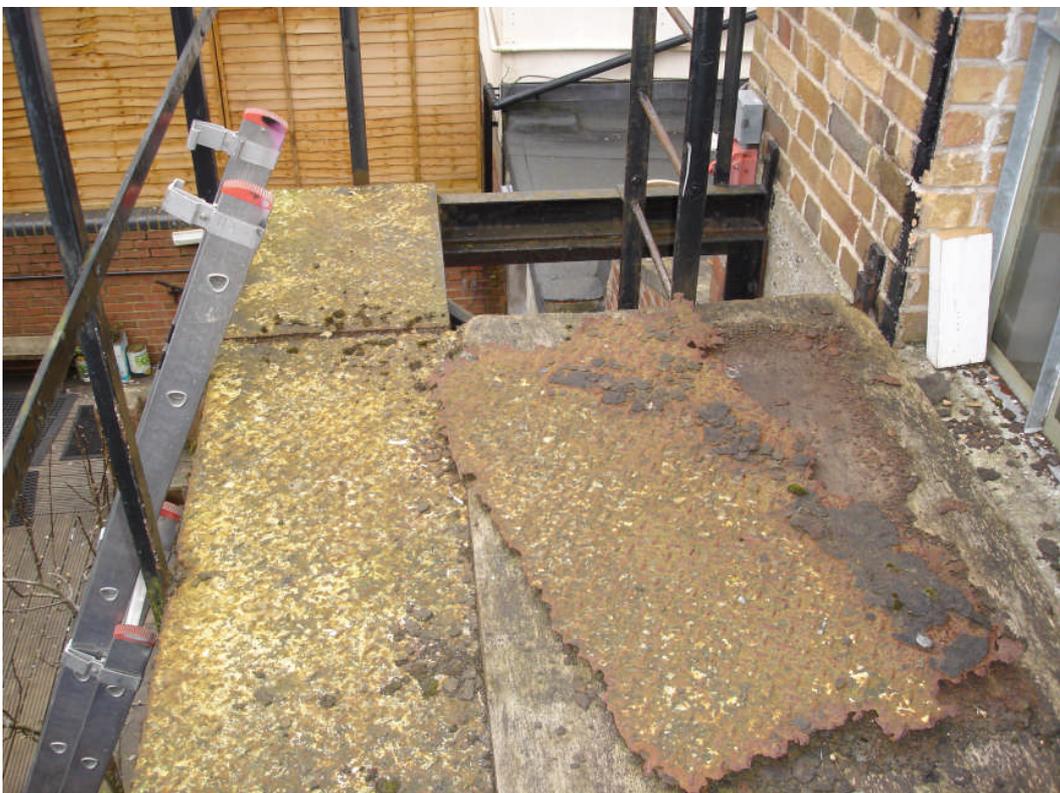
10 Dangerous and unusable fire exit from The Zone/stage area

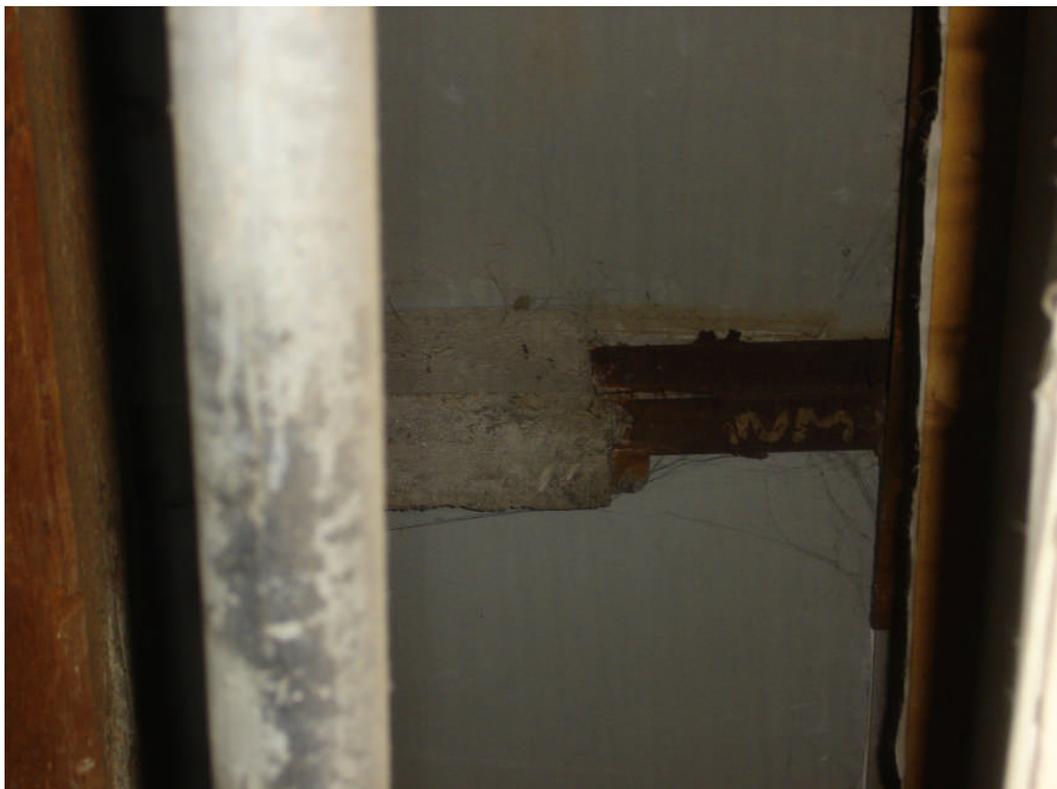
11 Suspected asbestos (damaged) material fire proofing structure to Fly Tower

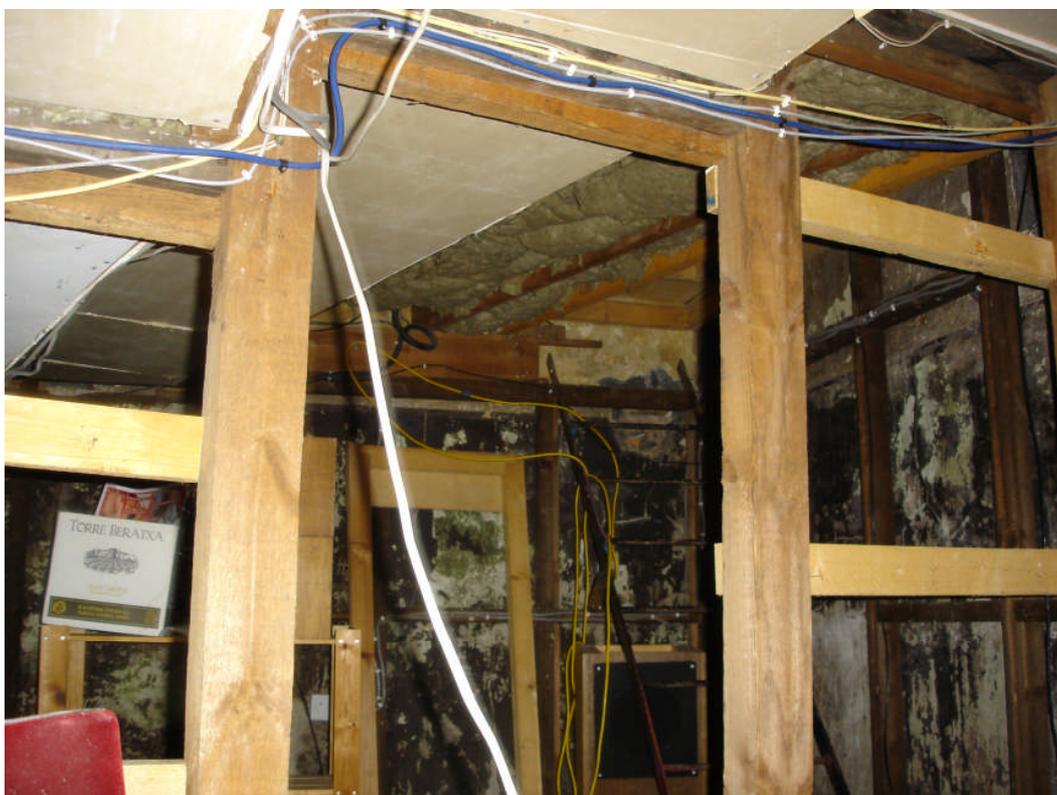
12 Deficient fire lining to the soffit of the auditorium seating
